Tripling of Production Area

Fiber in Existing Infrastructure

Challenges hidden in the ground...

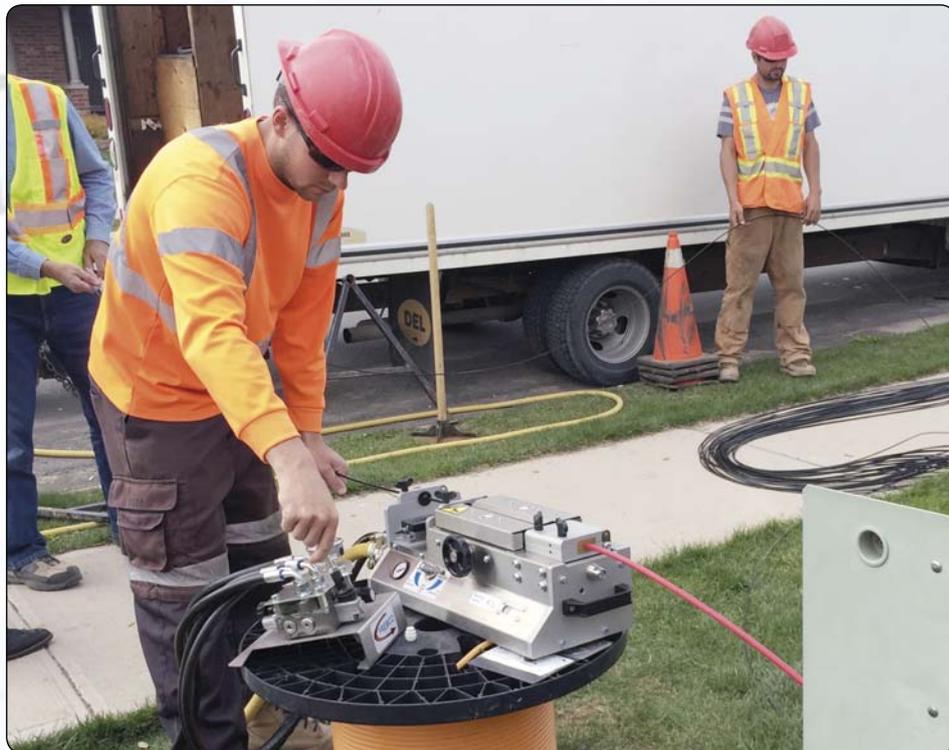
The MiniFlow RAPID machine showed that it can blow 1200 meter of fiber into a microduct with many turns.

When they designed the duct layout in the existing area, they did not consider a later expansion. This meant that the layout of the new supply cable was very challenging. Almost 1200 m of cable was to go through two 180° and nine 90° turns. The first 550 meter through a pre-installed 4x10 mm multiduct. The next 150 meter through a new 10 mm microduct in a 1 1/2" duct with an existing 20 mm coax cable. And finally 450 meter through a 1 1/4" duct with a new 10 mm microduct.

mm coax cable and the 10 mm microduct. We ended up with a solution with a smaller coax cable, which was pulled through the large duct together with the 10 mm microduct. We then connected all microducts on the full stretch, and the cable was blown all the way through using a MiniFlow RAPID.

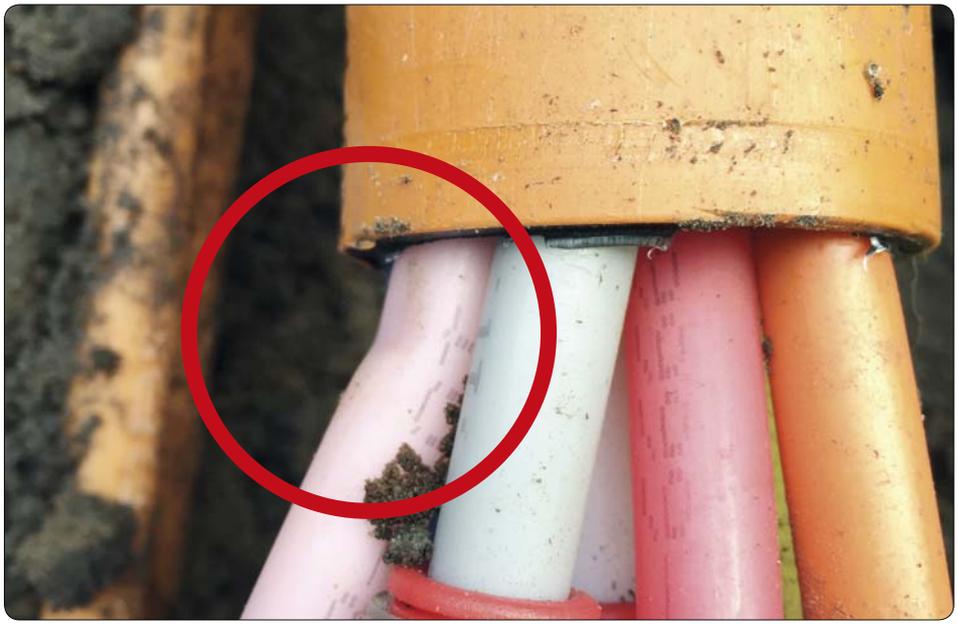
The picture is clear. The inner diameter of the microduct has been reduced by more than one third, and the fiber cable can obviously not get through irrespective of amount of air or the performance of the blowing machine.

The digging-up shows that the contractor, who originally relined the duct, neglected to stagger the connectors while connecting the microduct ends. You can see this in the picture to the left. Having repaired the damage, the remaining blowing process went smoothly and without problems.

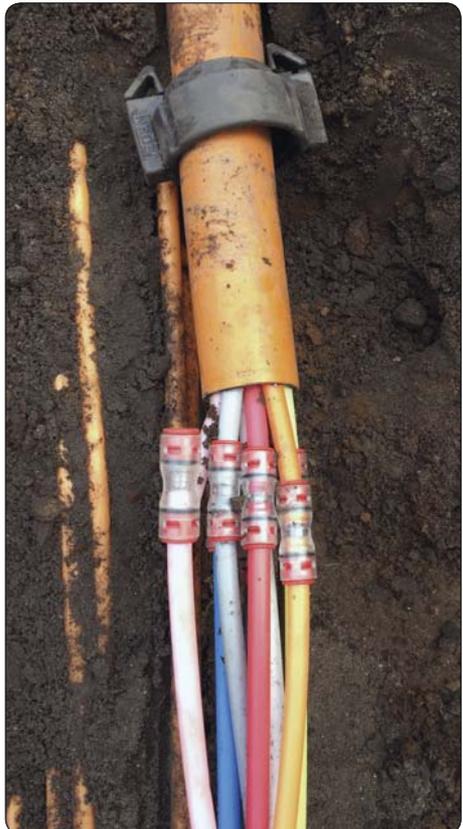
The microducts are tight and allow foam sponge and air to pass. Unproblematic on the face of it. Please note that all connectors have been placed right next to each other very close to the main duct. This means that the total diameter of the microducts by far exceeds the inner diameter of the main duct. And in this case the result is two bent ducts. Had the connectors been staggered by the length of a couple of connectors, the problem would never have occurred.

The pictures shown here are from a job in a Danish urban zone stretch in Mid Jutland. The situation is that a 40 mm main duct has been relined with seven 10 mm microducts over a stretch of approx. 6,500 meters, obviously with various connections on the way. The duct arrangement in the wells is fine, but the ducts are not of recent date. Most of the ducts are already occupied.
